44TH TURBOMACHINERY & 31ST PUMP SYMPOSIA
HOUSTON, TEXAS | SEPTEMBER 14 – 17 2015
GEORGE R. BROWN CONVENTION CENTER

CFD STUDY OF FAILURE IN AN OIL FLOODED SCREW COMPRESSOR JOURNAL BEARING

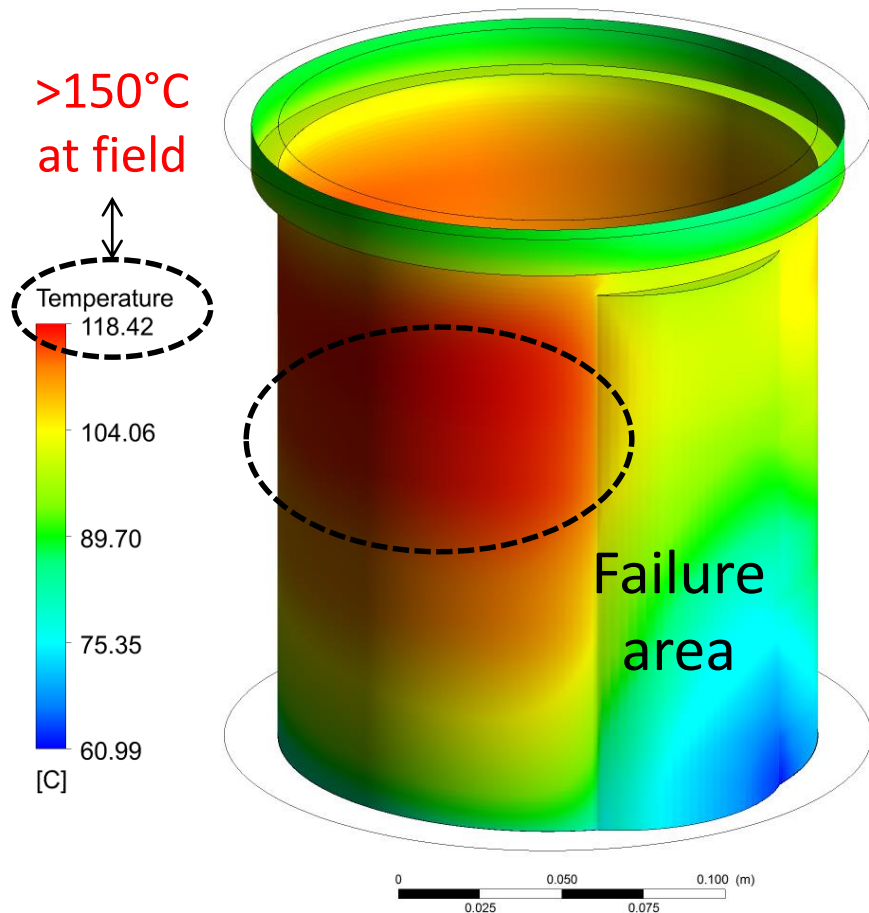
Before modifications

- Temperature profile at **oil-bearing interface**:

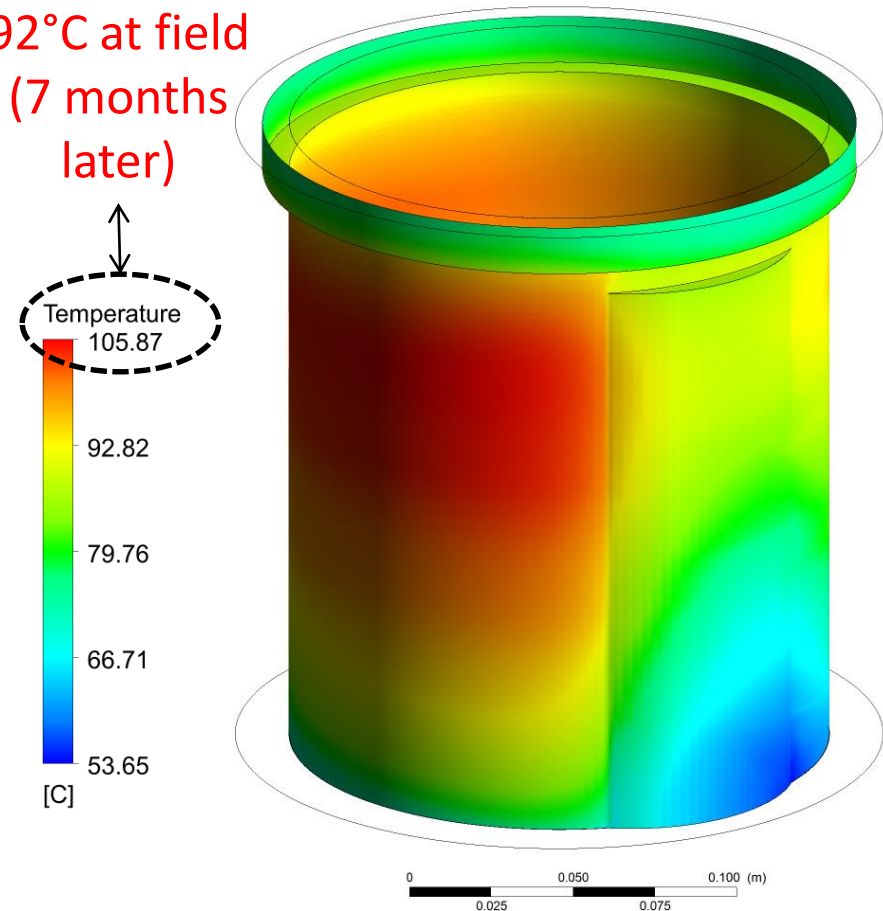
After modifications

92°C at field
(7 months later)

- **Male NDE** clearance increase (0,19 to 0,24mm)
- Oil change (Kluber PGS 150 to PGS 100)
- Oil pressure increase (+2,5bar)
- Oil supply temperature reduction (50°C to 45°C)
- Individual oil injection to male NDE bearing
- Oil injection's logic modification to prevent an eventual oil pressure drop in the oil header
- Suction pressure reduction (1,80 to 1,35bara as designed)

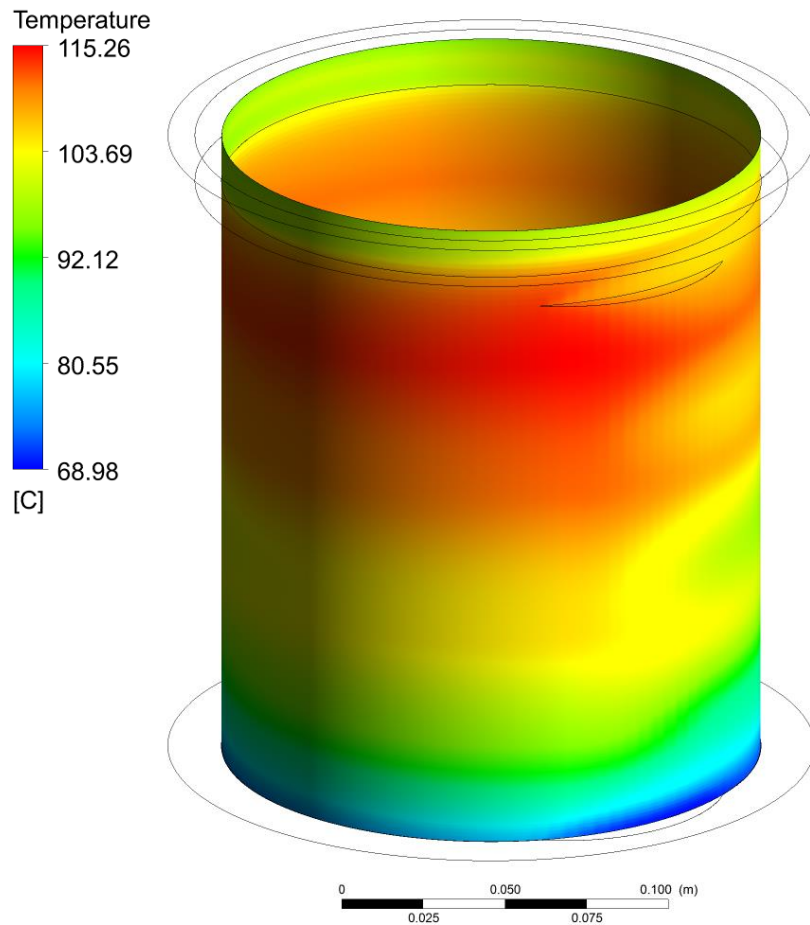
Before modifications

- Temperature profile at **oil-shaft interface**:

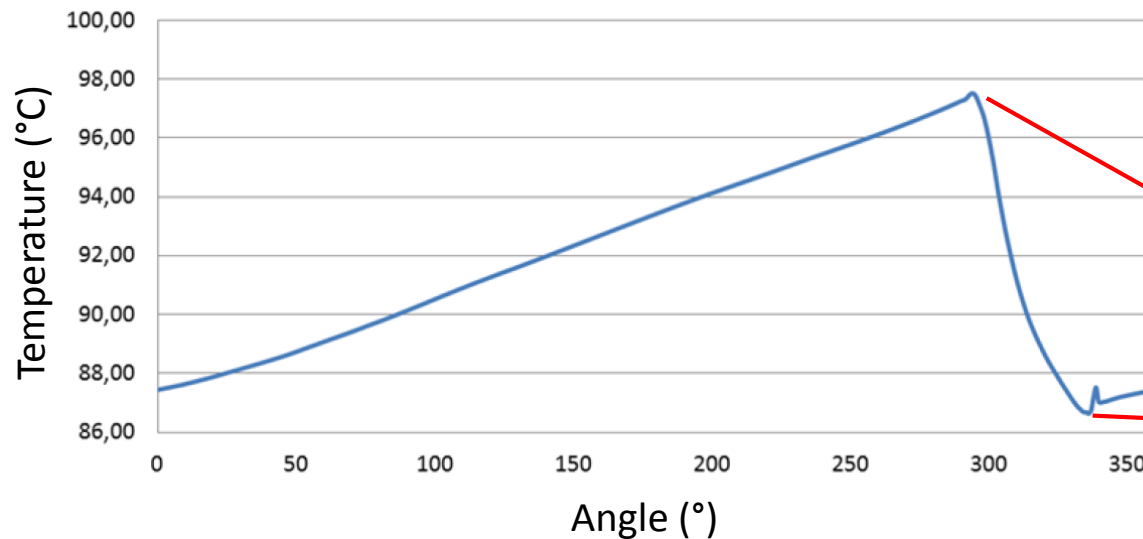
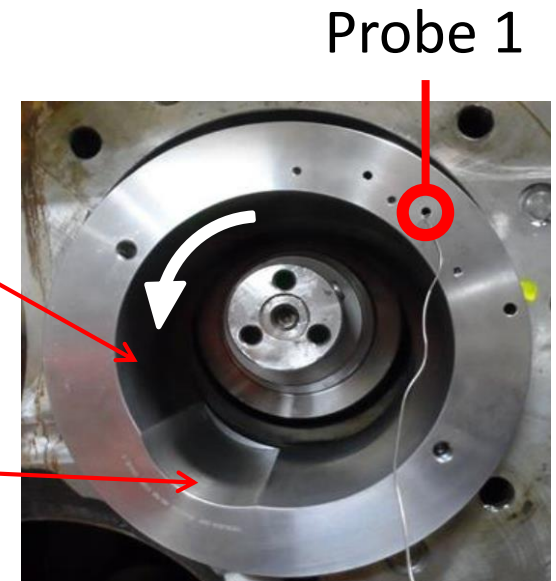
Temperature at probe 1 cross section after modifications

- Stabilized around 92°C after 7 months

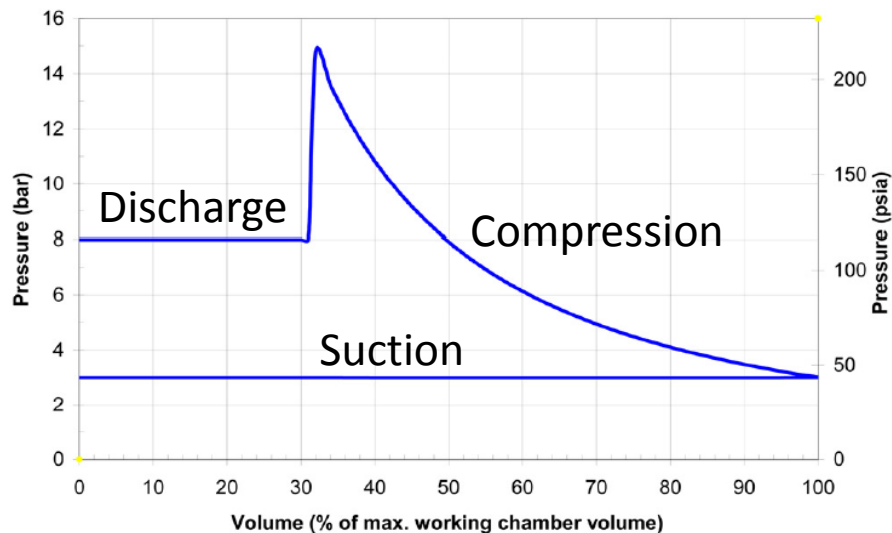
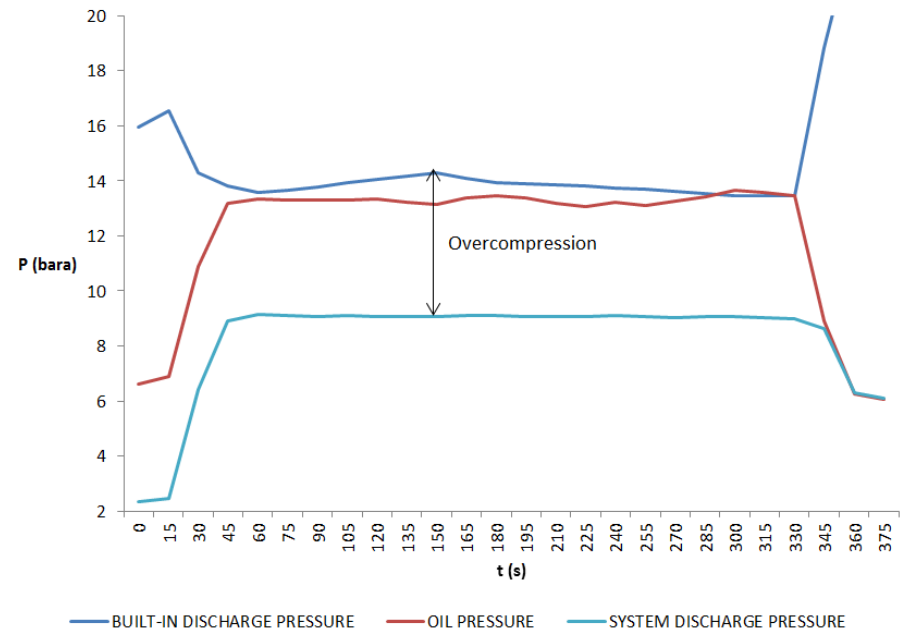
- High suction pressure, leading to an increase of built-in discharge pressure
- Oil pressure could be lower than the built-in discharge pressure, allowing gas into the bearing

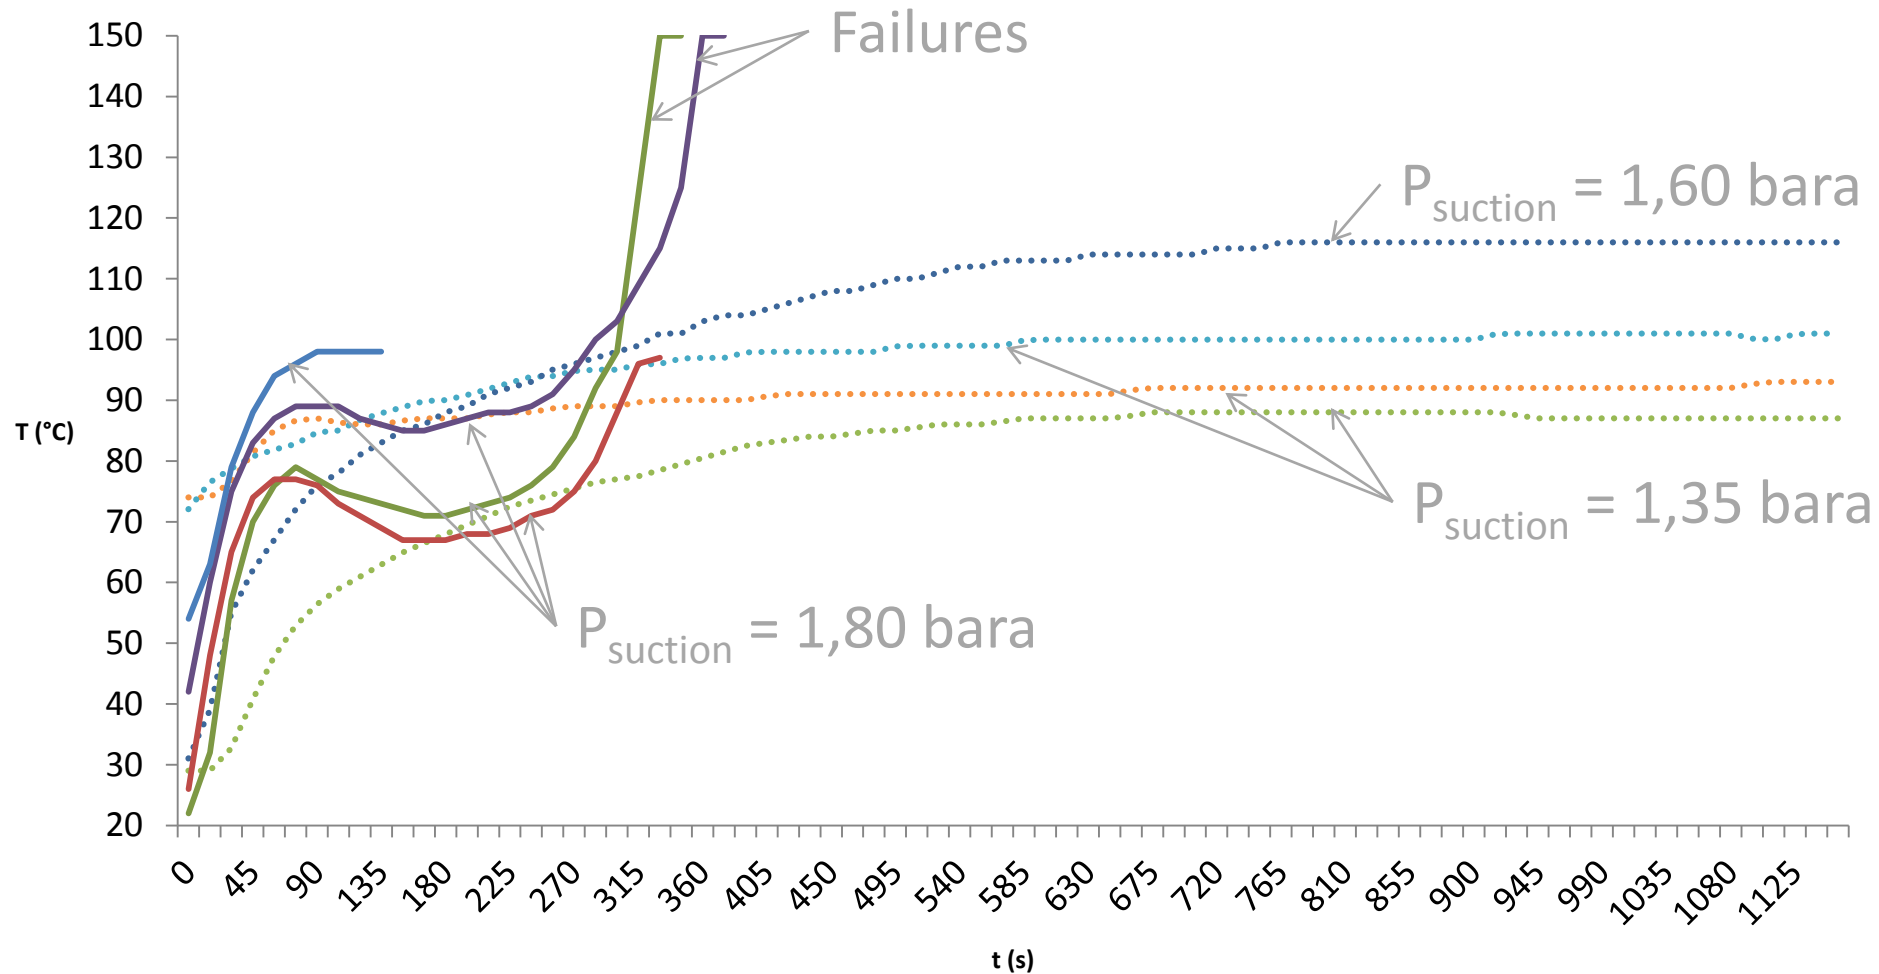
- All bearing temperatures were reduced and stabilized:
 - **Male NDE:** $>150^{\circ}\text{C}$ to 92°C (7 months later)
 - **Male DE:** 111°C to 79°C
 - **Female NDE:** 111°C to 85°C
 - **Female DE:** 101°C to 75°C
- No visible impact on vibration (machine monitored only by two frame accelerometers)

01/02/15 (Kluber 100) 16/11/14 (Kluber 100) 09/09/14 (Kluber 100) 15/08/14 (Kluber 100)
 18/07/14 (Kluber 150) 06/07/14 (Kluber 150) 03/07/14 (Kluber 150) 02/07/14 (Kluber 150)
